# The Economics and Truth about HVAC Asset Management with Testing and Restoration

VSPMA  
June 8, 2026

# Pure Air Controls Services (PACS) – Tremco's HVAC/Mechanical offering:

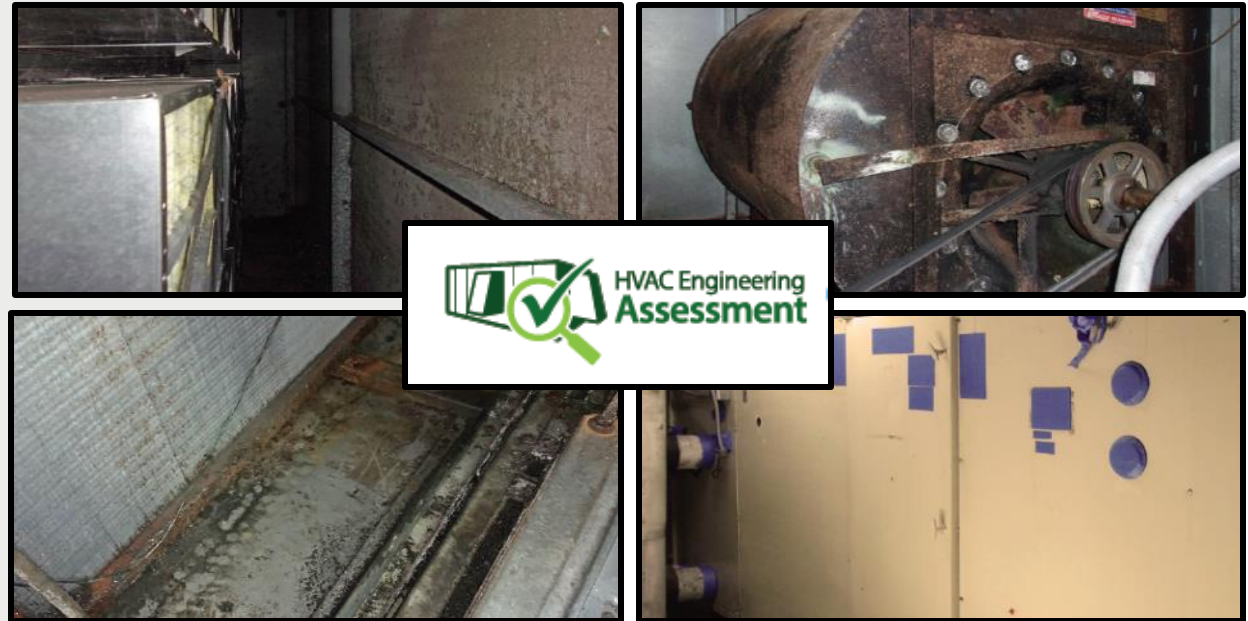
| Brand: | Carrier air handler | Model: | 39ED3629444 | | Serial: | | Size (L-W-H) | 80-58-100 inches | Dx or CW= | CW |
| Component | | Finish / Type | | Fouling Level | Hygienic Recommendation | | Aging Level | Refurbish/Upgrade | | Additional Notes |
| Return Air Mix Plenum | | Mechanical Room | | 4 | Cleaning is highly recommended | | 5 | Upgrade is recommended | | Breaches on mechanical room wall need to be repaired |
| Blower Cabinet | | Sheetmetal /Closed Cell | | 3 | Cleaning is recommended | | 2 | None | | Heavy Moldiness |
| Supply Air Plenum | | Sheetmetal/ liner | | 6 | Cleaning is highly recommended | | 4 | Refurbish is highly recommended | | Heavy Moldiness |
| Totals | | | | 33 | | | 29 | | | |
| | | Overall Score | | 61.1% | | | 53.7% | | | |

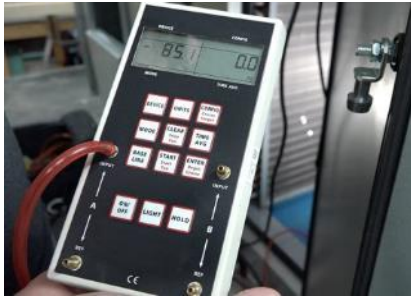
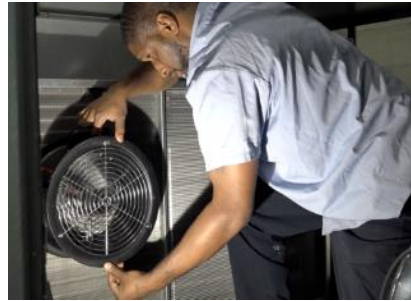
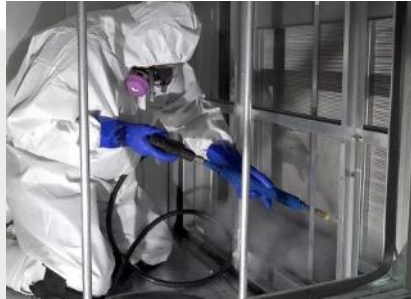
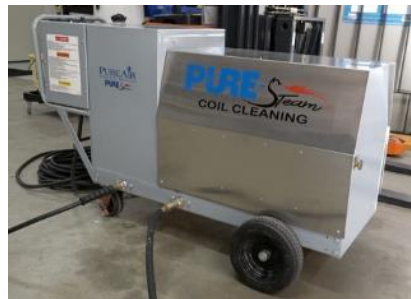
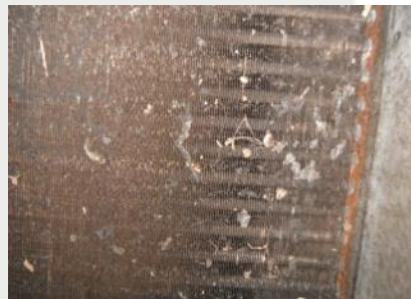
# PURE-Steam AHU Cleaning Program

Thorough, deep sanitization utilizing high temperature and low-pressure steam along with bio-enzyme coil treatments.

- Static Pressure Readings
  - Before & After
- Containment & Masking
- HEPA vacuum interior of AHU
- Steam Cleaning: 350-degree F
- Water Extraction & Final Flush

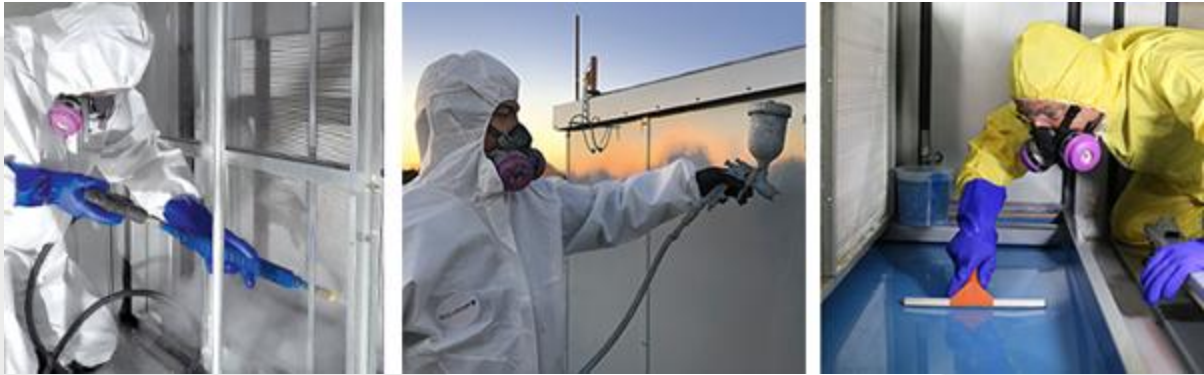
# HVAC Restoration Coatings

- Prep by sandblasting and/or hand sanding
- 2-part, multi-siloxane coating
  - Polyurethane
- Water-based for interior
- Solvent-based for exterior
- Low odor/VOC
- Tested for:
  - pH/Acid
  - Sea Salt
  - UV
- Designed and certified for use INSIDE the air conveyance system

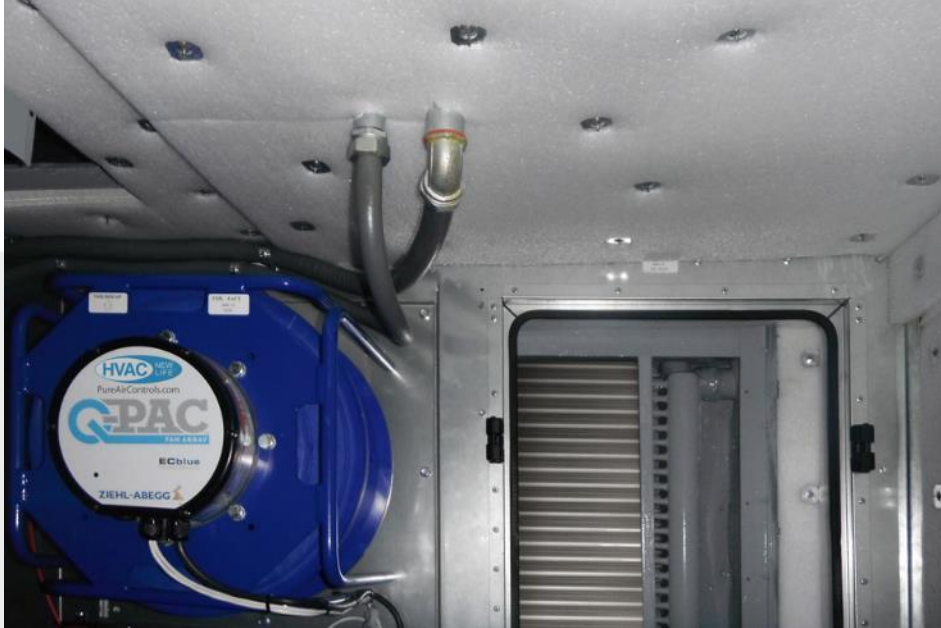
# HVAC Fan Retrofit Benefits

- Simple, Complete Retrofit
- ECM Fans
- Bulkhead/Array Assembly
- Point Power
- No VFDs, Grease or Belts
- Built-In Redundancies

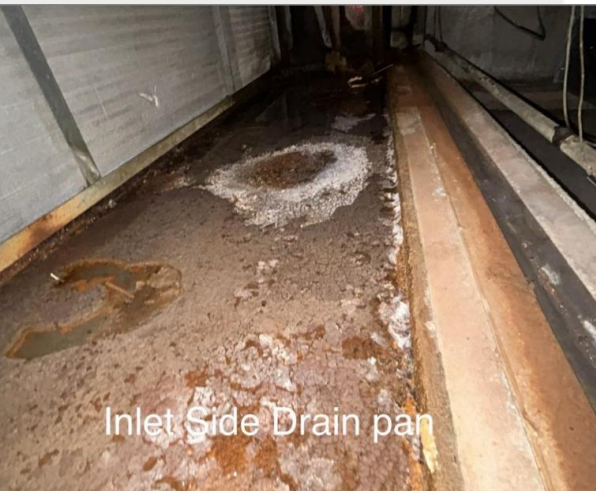
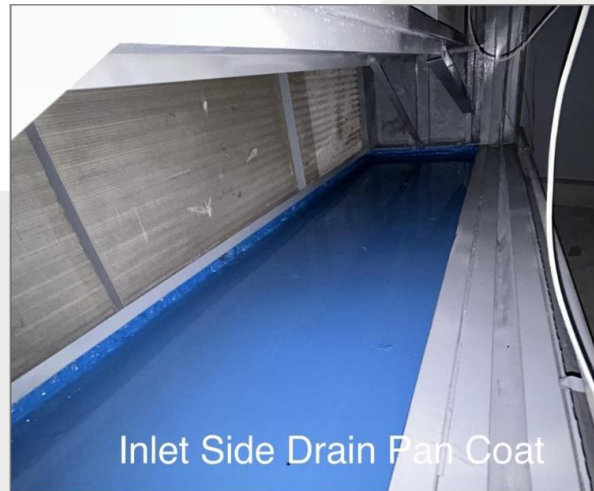
## Riverside Health System – Riverside Regional Medical Center.

### 2 Roof Top Units

- Scope
  - PURE-Steam
  - PURE-Liner
  - PURE-Coat Exterior
  - PURE-Coat Interior
- Restorations prioritized and spread across fiscal year budgets.
- Mechanical Asset Preservation Plan in motion.

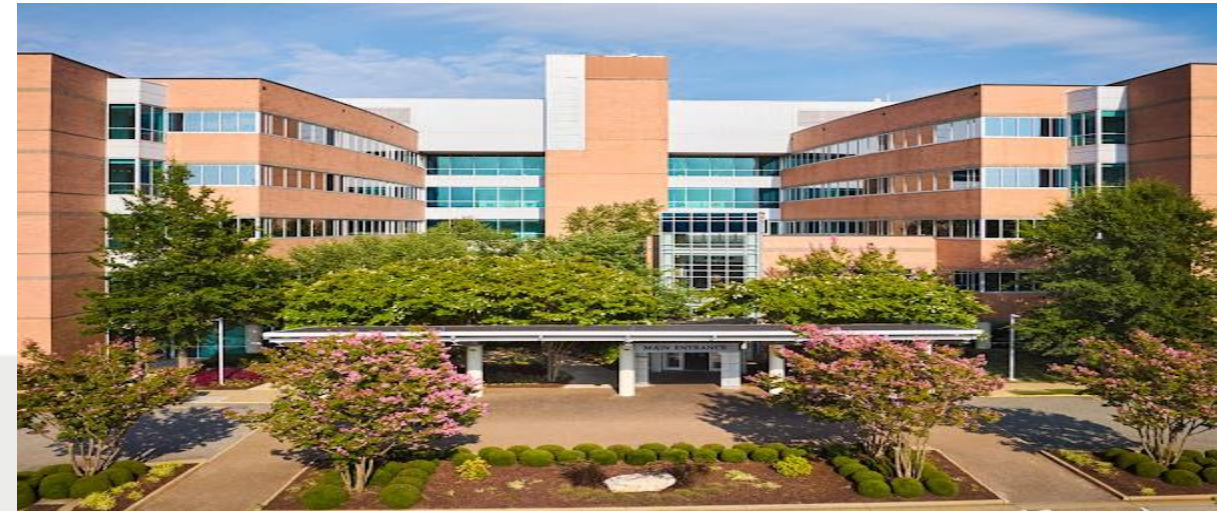
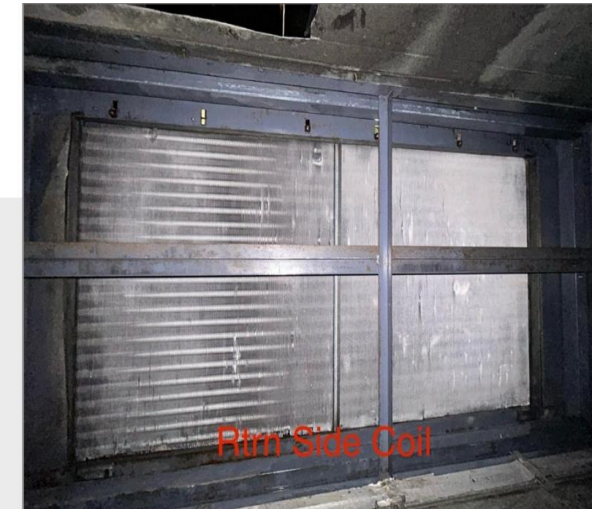
## Sentara CarePlex Hospital – Hampton VA

### Interior AHUs

- Scope
  - PURE-Steam
  - PURE-Liner
  - PURE-Coat Interior
- Unit replacement would be costly, disruptive and outside desired completion date.
- Restoration performed over off-hours in 4 shifts per AHU.

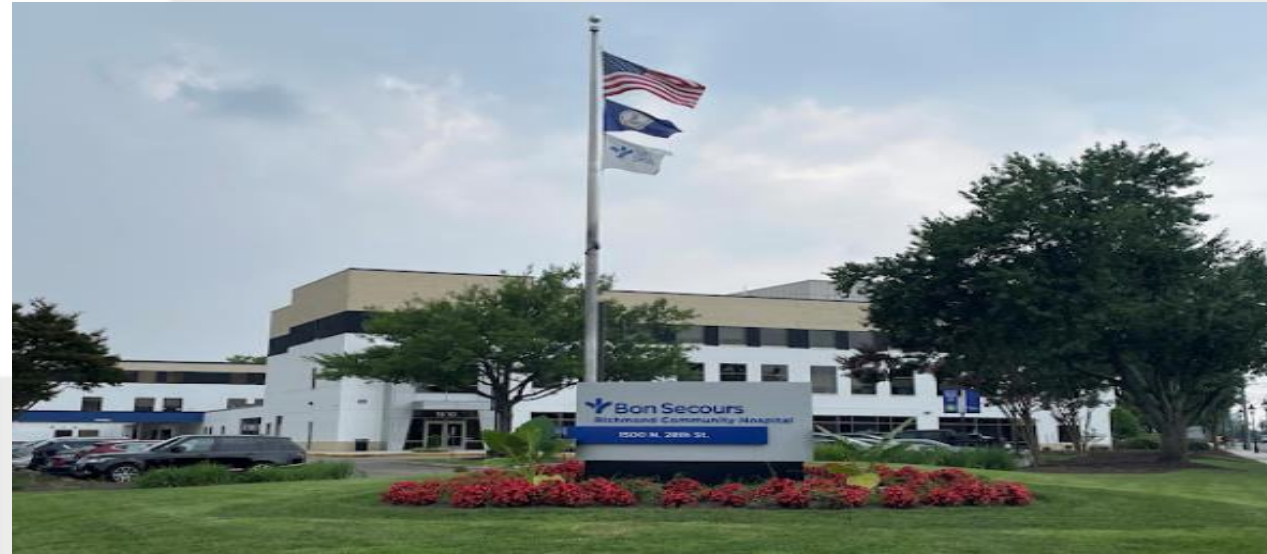
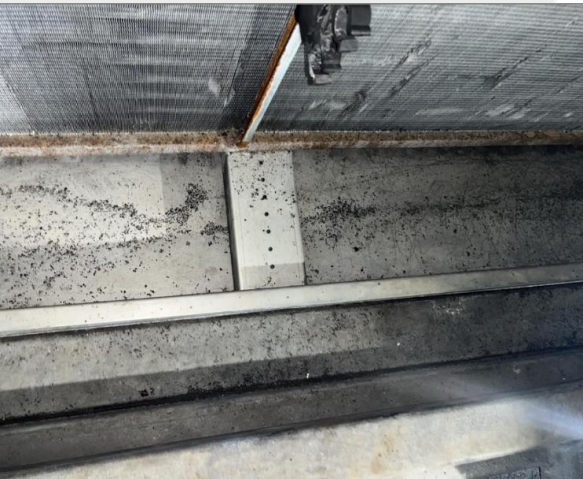
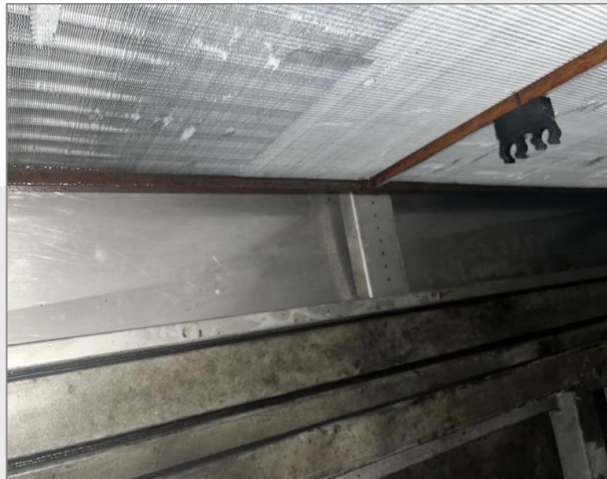
## Bon Secours Richmond Community Hospital

### 2 AHUs

- Scope
  - PURE-Steam
- Emergency cleaning requested by customer.
- Onsite crew completed first AHU in 1 shift rather than scheduled 2 shifts.
- Used 2<sup>nd</sup> shift to PURE-Steam the next AHU on priority list.
- Post-test readings show marked Delta P decrease in both AHUs.

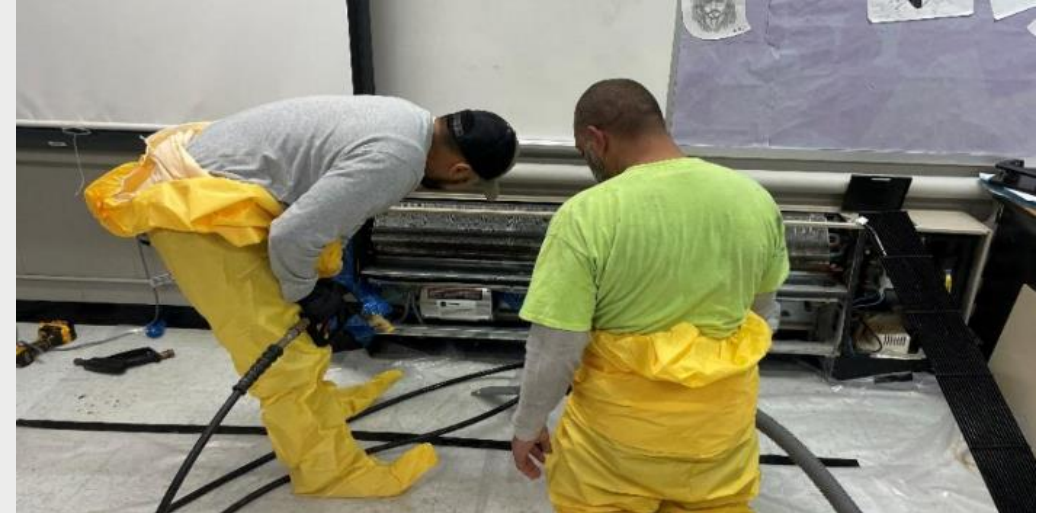
## Case Study – Metro Nashville Public Schools

- Fan Coil Units –1,200 CFM design
- Pre-clean CFM readings 309 & 403.
- Post-clean CFM readings 826 & 1,229.
- **267% & 305% increased airflow.**
